Slope Stability Monitoring Using Remote Sensing Techniques

SLOPE STABILITY MONITORING USING REMOTE SENSING TECHNIQUES

A thesis submitted in partial fulfillment
of the requirements for the degree of
Master of Science in Civil Engineering

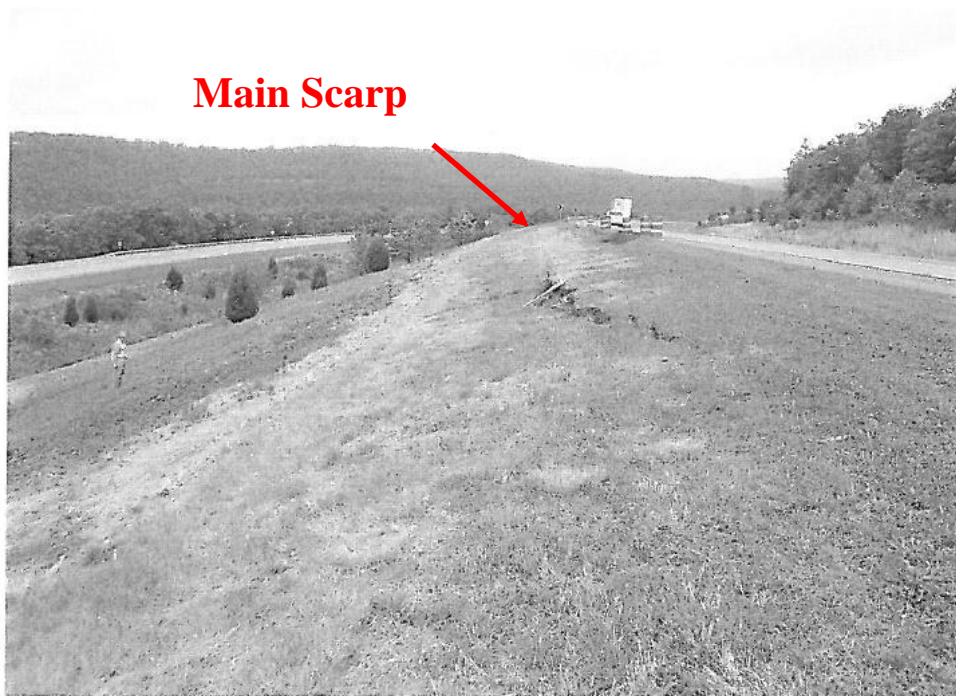
Figure 3.3. Looking north to the main scarp at the calibration site near Chester, Arkansas in May 2010 (from AHTD, 2010).

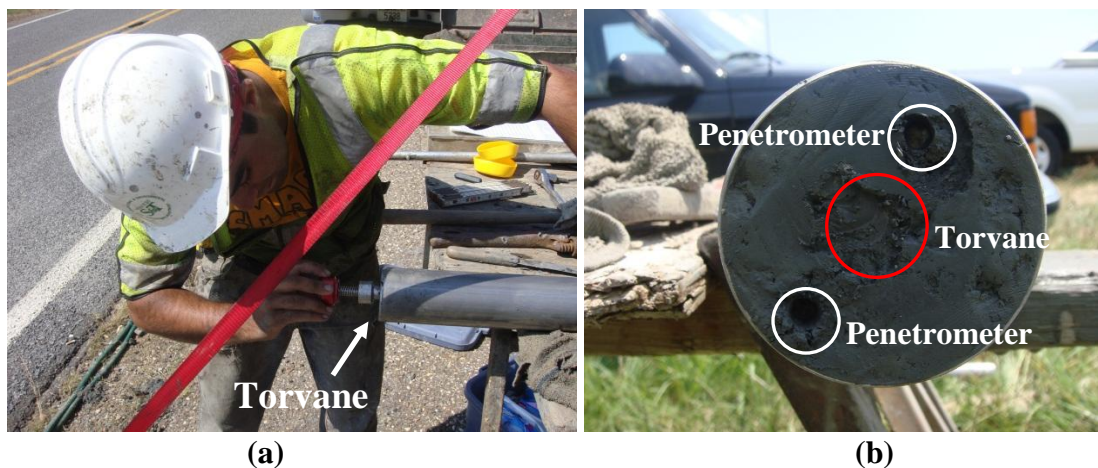
Figure 4.34. a) Torvane test being performed on a tube, b) index test locations.

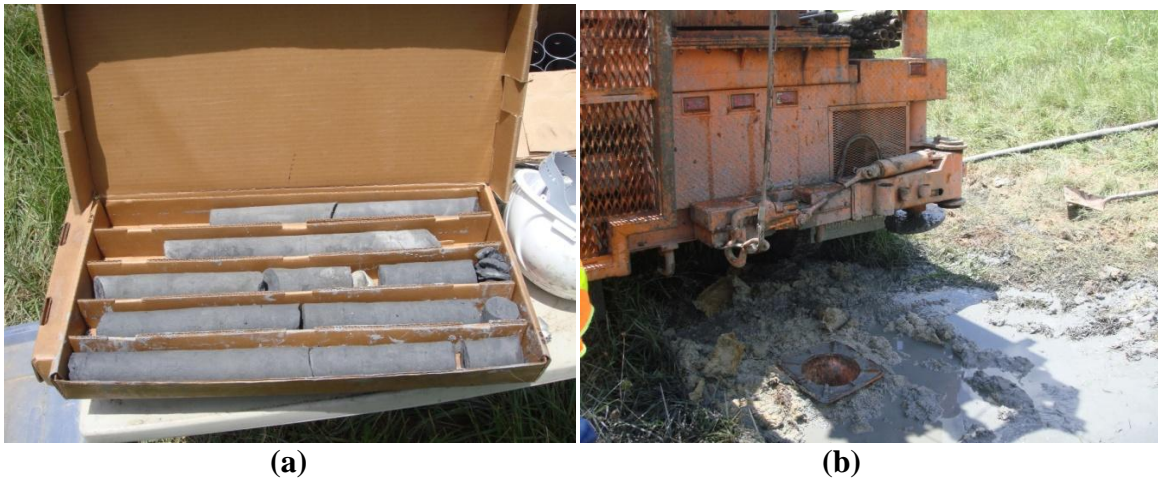
Figure 6.3. a) Rock sample obtained coring at B-2 (validation site), and b) post-drilling conditions at B-2

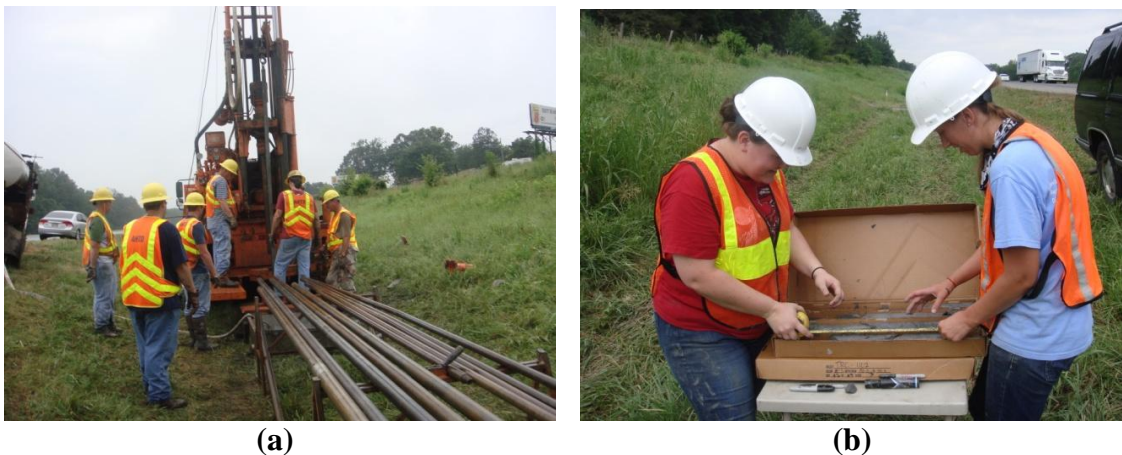
Figure 6.4. a) Drilling operations at B-3, and b) measuring RQD of rock sample obtained from B-3.

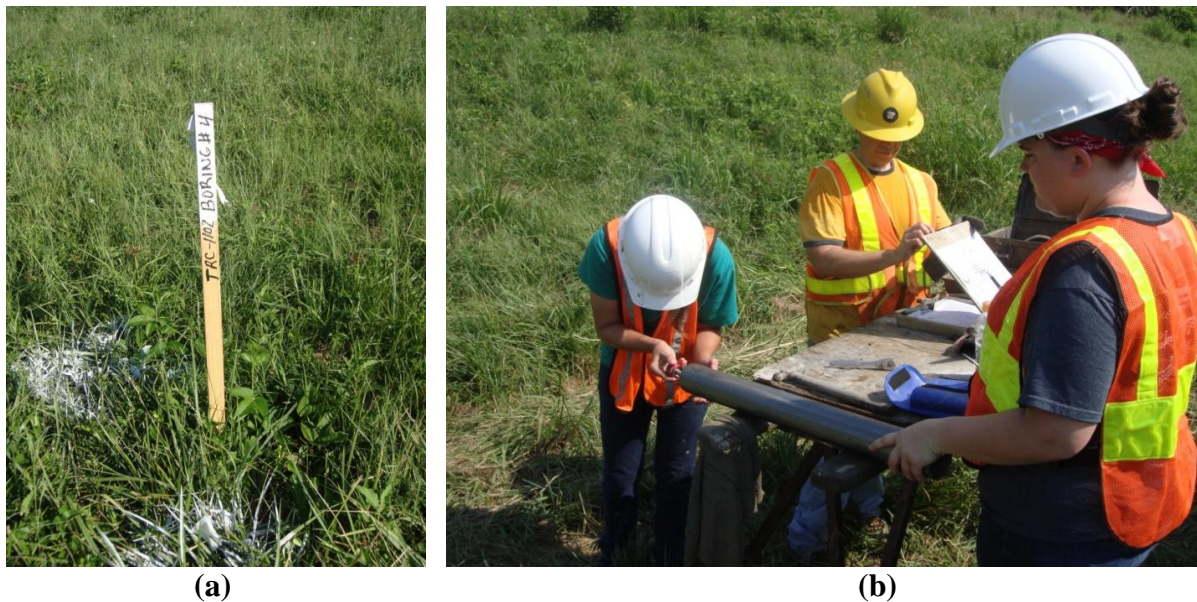
Figure 6.5. a) Pre-drilling conditions at B-4, and b) torvane test being performed in Shelby tube soil sample .

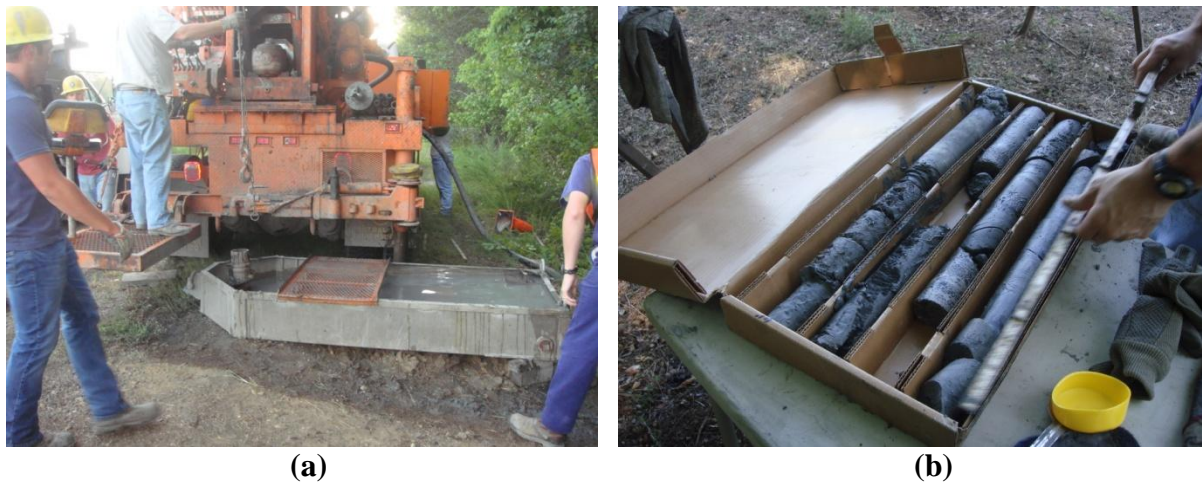
Figure 6.6. a) Changing to rotary wash method at B-6, and b) rock sample obtained from B-6.

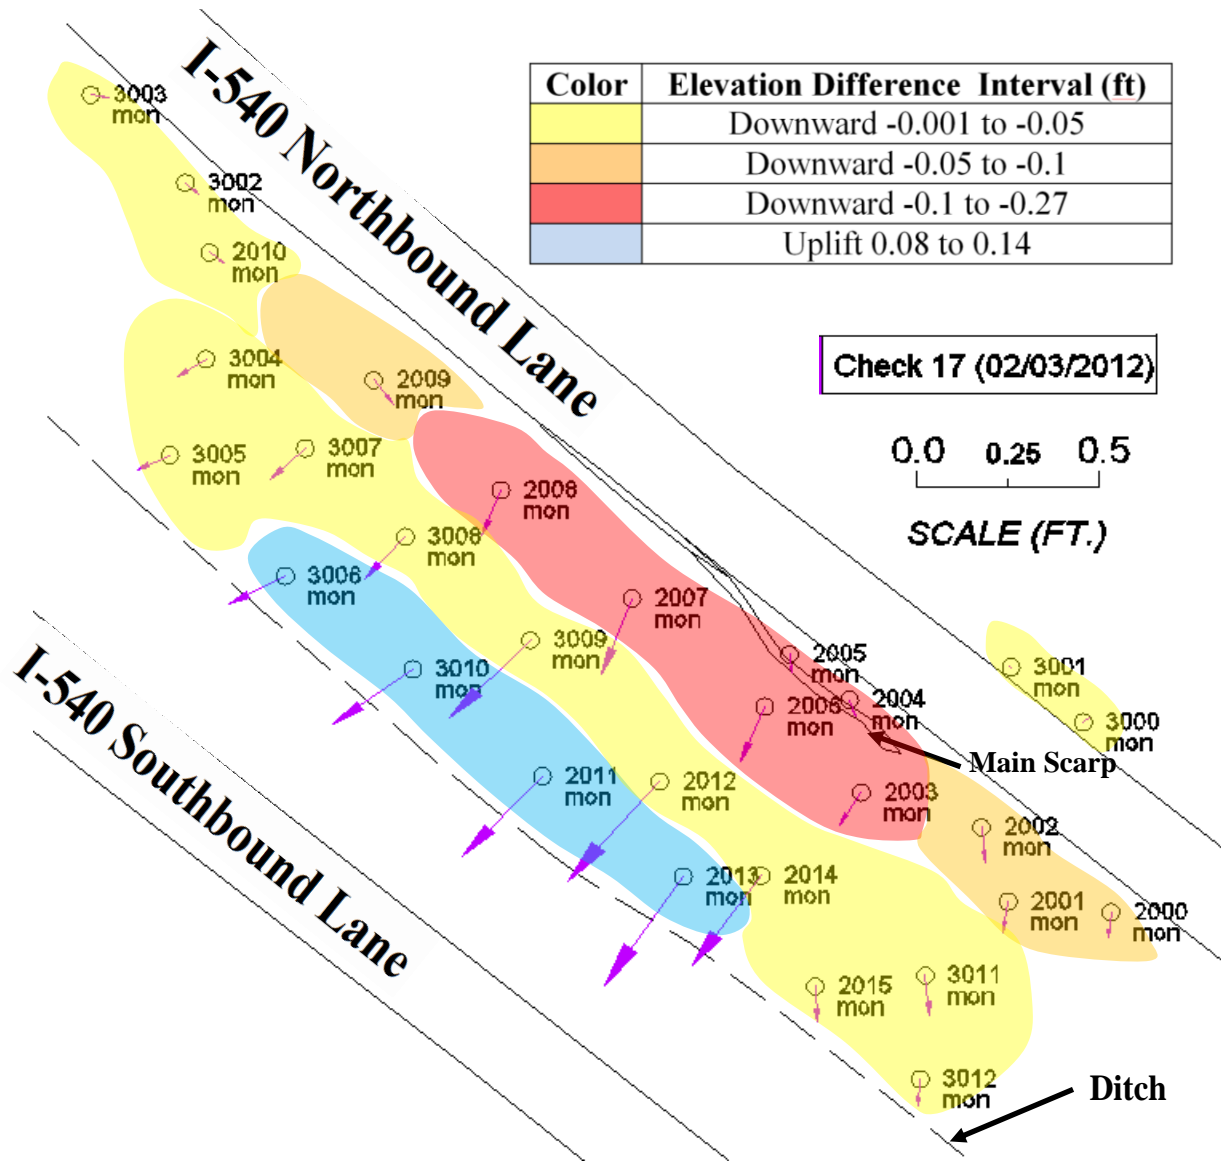
Figure 6.21. Zones of vertical movements for the calibration site; red zone represents largest down movements, orange zone represents down medium movements, yellow areas low to zero down movement, and blue areas represent uplift movement [in color].
