Andrew Kos^(1,2), Tazio Strozzi⁽³⁾, Reto Stockmann⁽¹⁾, Andreas Wiesmann⁽³⁾, Charles Werner⁽³⁾

Detection and characterization of rock slope instabilities using a portable radar interferometer (GPRI).

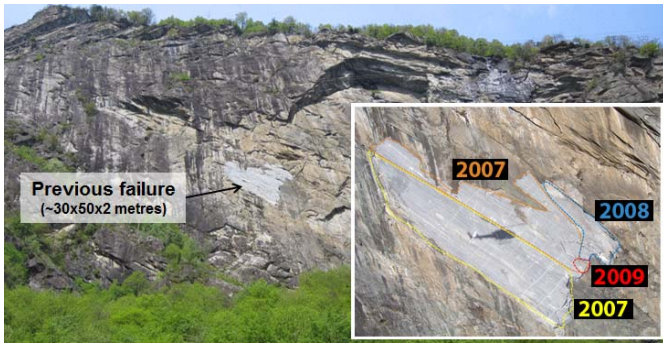
The locality consists of a rock wall approx. 600m in length and 300m in height that has been the scene of several block failures, the largest of which occurred in 2007 (~3000m³), followed by two smaller failures in 2008 and 2009 (Fig 2). The rock fall activity directly endangers a roadway running parallel near the foot of the slope in Canton Graubünden, Switzerland.

Figure 2 The rockwall at Soazza showing sites of previous block failure.

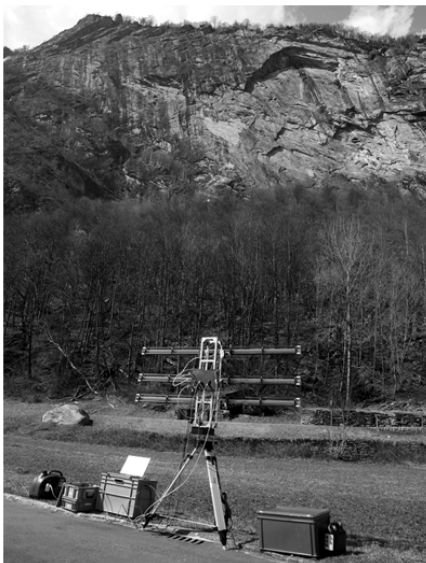
In collaboration with the state road authority of Graubünden, radar interferometric measurements were undertaken as part of research project into rock fall release mechanisms in March 2010. Repeat measurements took place in May and August of the same year. Measurements were undertaken with the GPRI-I using a standard geodetic set-up, where the radar was levelled and centred with reference to a fixed survey point (Fig 3). During each campaign, 3-4 hours of continuous data was acquired with the antennae programmed to rotate through a sector of about 70° .

Figure 3 Set-up of the GPRI-I at Soazza using a survey tripod, levelled and centred with respect to a fixed point.

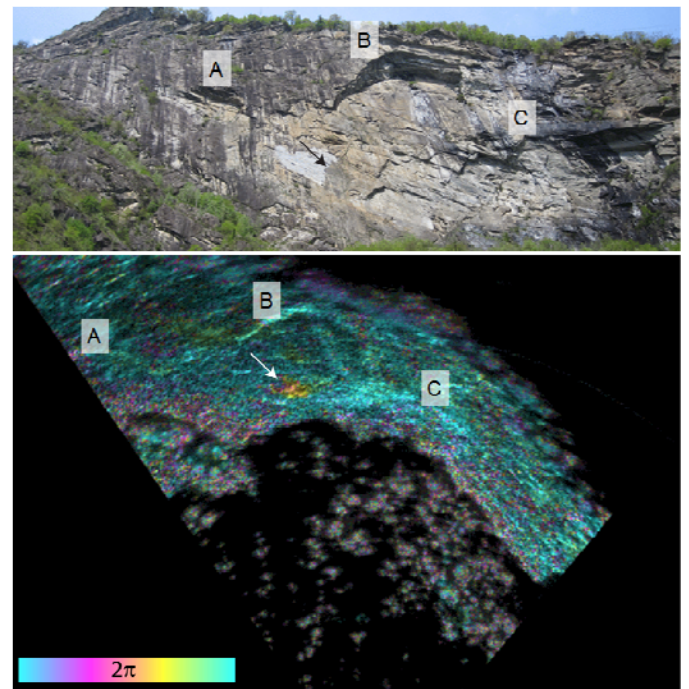
Results of the March – August 2010 campaigns are shown in figure 4 as a 5 month interferogram depicting cumulative displacements for the three measurement campaigns undertaken.

In figure 4, a reflectivity image (e.g. intensity of backscattered energy) is overlain by a filtered interferogram where atmospheric phase noise has been removed. Points, A, B and C have been included to aid the reader's orientation with respect to the rock wall. Clearly visible is the slightly defocused top edge of the rock wall (which is lined with vegetation), areas of

backscattering consisting of both strong and weak natural reflectors, and forested areas directly at the foot of the rock wall. Coherent signals are evident on the rock wall, whilst decorrelation is notable in the vegetated areas.

Figure 4 Interferogram showing total displacements for the period March – August 2010.

Details of the March to August radar acquisitions are shown as a series of interferograms in figure 5. Interferograms in figure 4 are displayed in radar coordinates (e.g. range and azimuth). "A" demonstrates the relatively good phase stability for the reference measurement taken in March 2010, "B1" is an unfiltered interferogram for the period March-May 2010 showing a linear atmospheric effects on phase, whilst "B2" has atmosphere removed using a low-pass filtering method. A notable feature in "B2" is the emergence of a weak signal corresponding to the rock block adjacent to the failure from 2007 (deformation signal indicated with arrow). "C2" shows the interferogram for the interval May-August 2010, where the previous "weak" signal is stronger and more evident (deformation signal indicated with arrow).

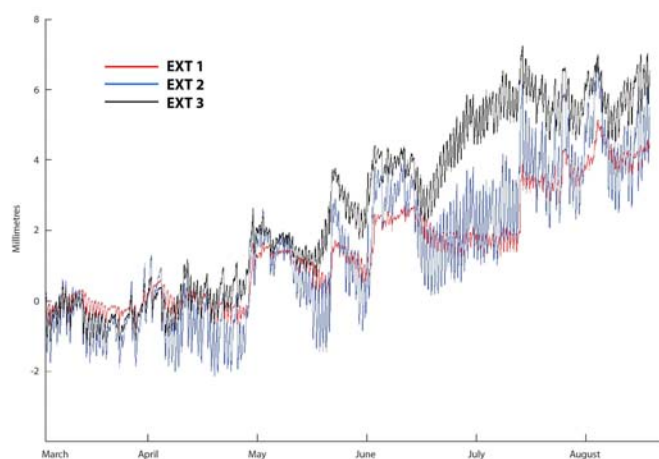
In addition, preliminary analysis of three *in situ* crack meters located on the left margin of the rock slab; (EXT 1-3 in fig 7) show a greater degree of displacement occurring on the middle section (EXT 2 & 3) of the block compared to the upper part (fig 8).

Figure 8 Displacement trends for 3 *in situ* crack meters located on the left-hand side of the rock slab (see fig 7 for location of crack meters).
